New York State Department of Transportation

Yellow Flag NB22CTW003

BIN: 1065318

Location: Span 125 Girder G7 at Pier 124

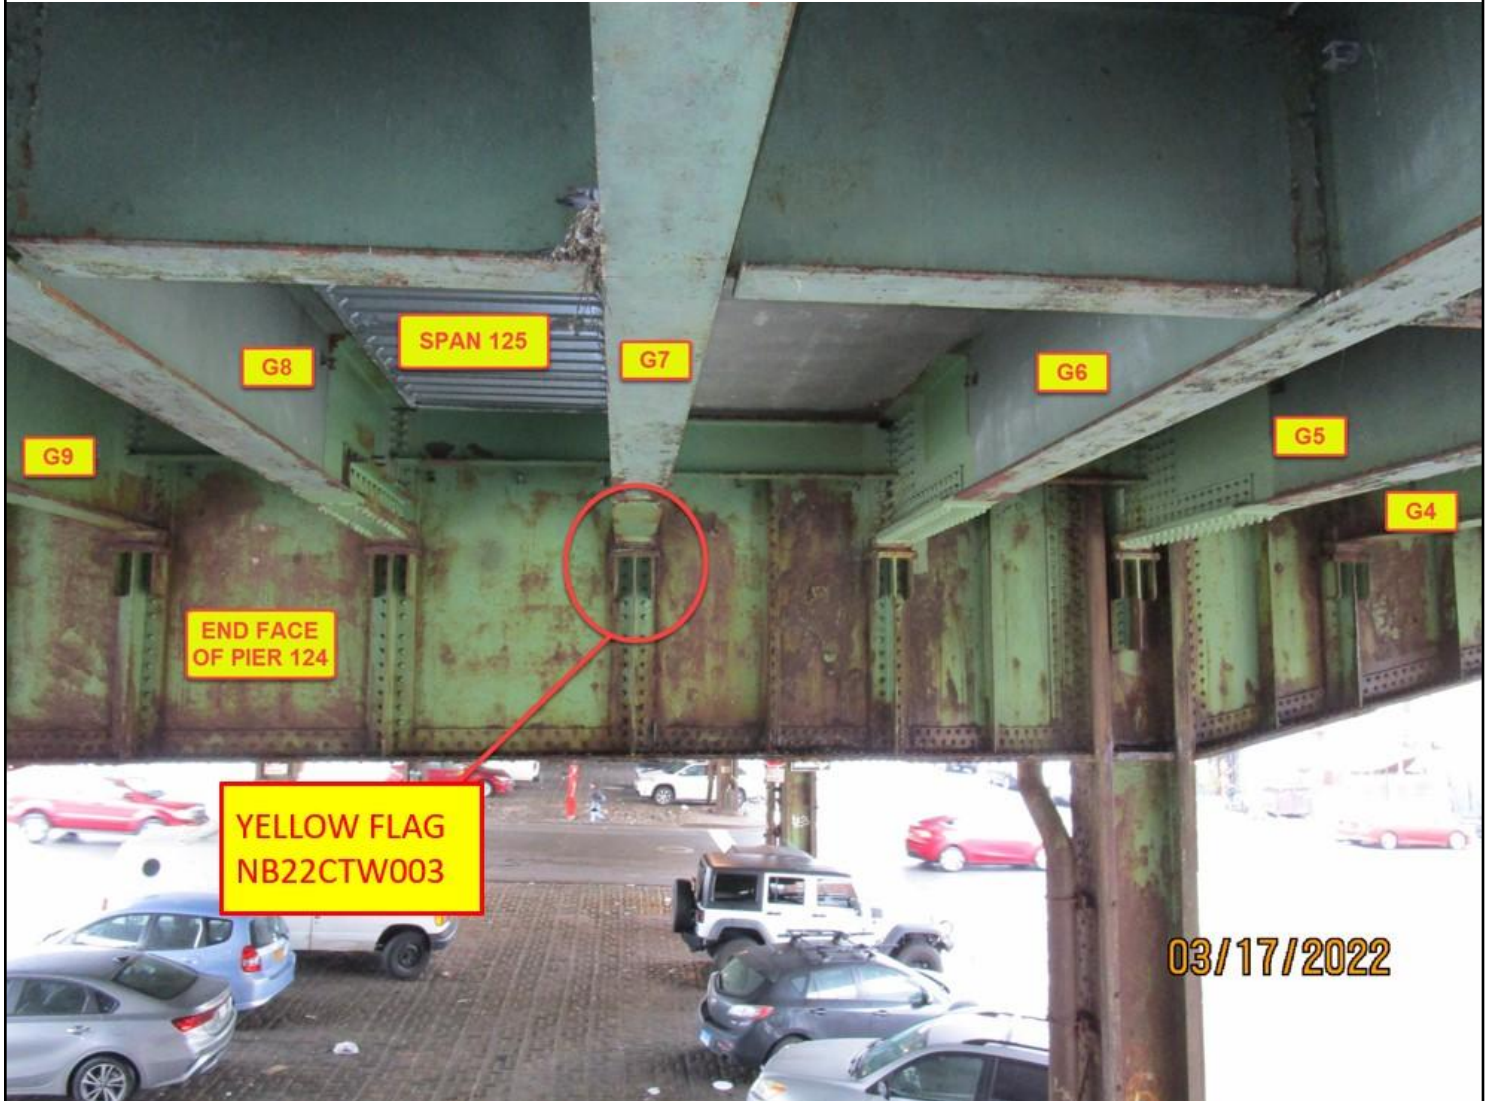
Photo Number: 1

Attachment Description: General view of Girders G4 thru G9 in Span 125 at Pier 124 showing the reinforcement plates at Girders G6 and G8. Looking Begin.

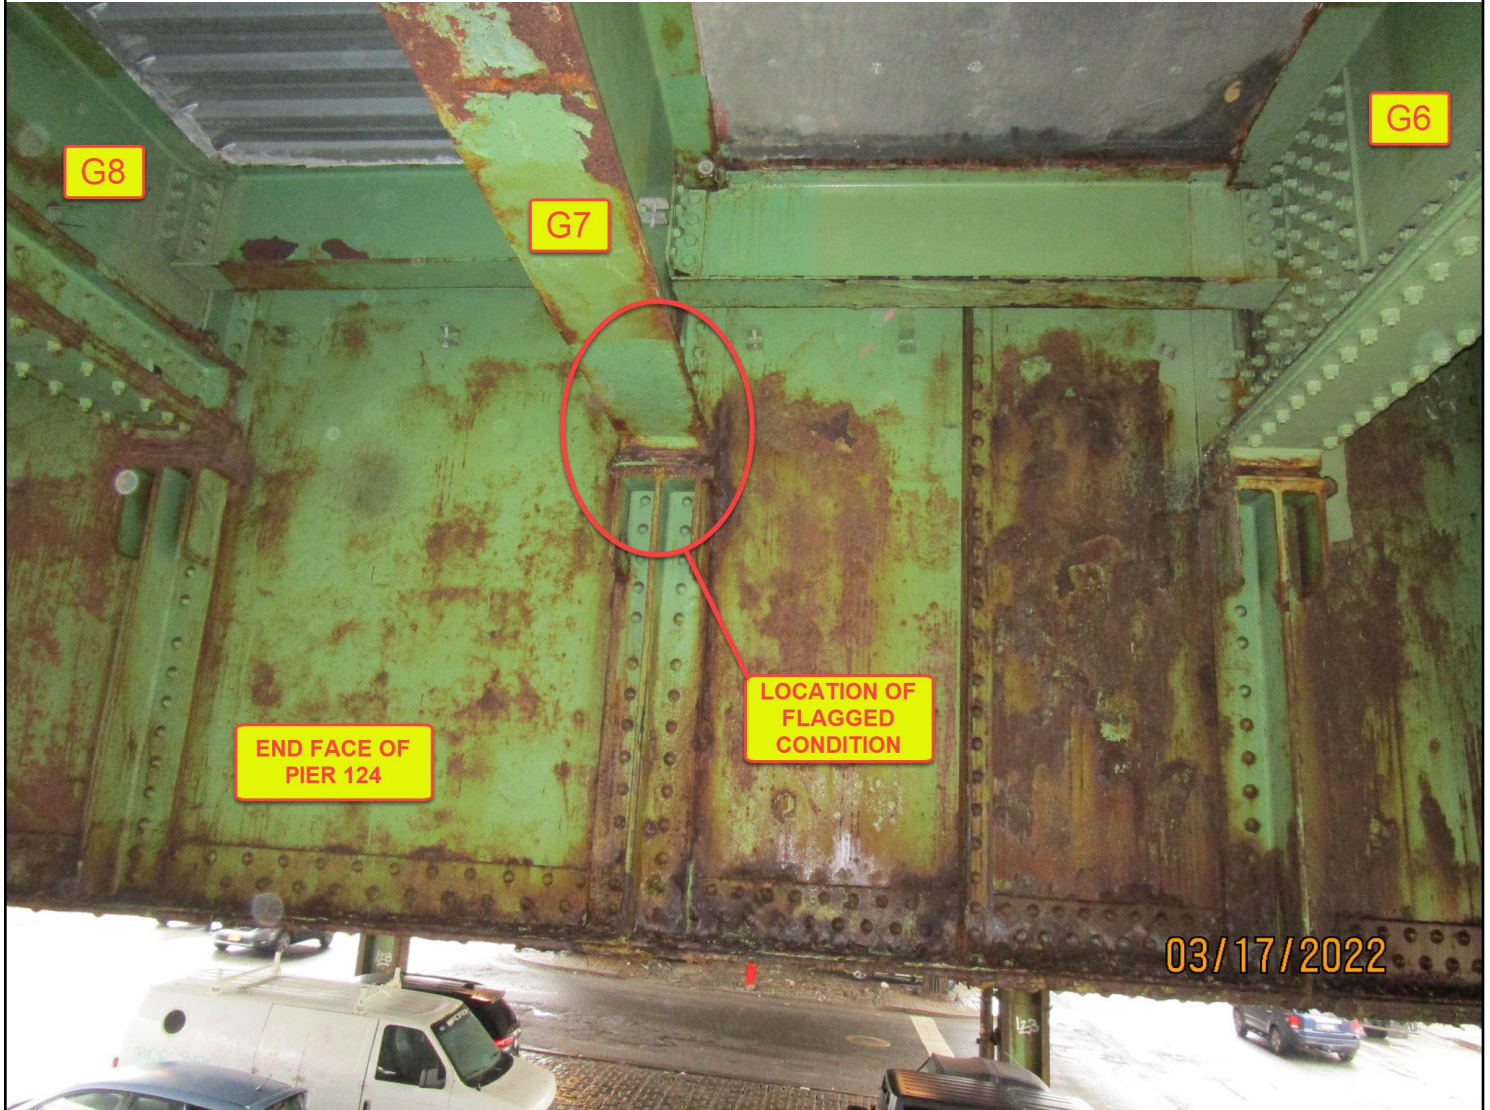
Photo Number: 2

Description: The end of Girder G7 in Span 125 at Pier 124 exhibits severe corrosion resulting in an overall web bearing area section loss of approximately 56% (no change from the previous inspection) and an overall shear web area section loss of approximately 19% (no change) with an average overall localized section loss of approximately 51% (no change) for 5"L x 4"H area directly above the bearing below the guide angle (Photos 3 and 4). Also, the lower web of the girder adjacent to the web bearing area exhibits average 20% section loss for 2'L x 3"H above the bottom flange. There is no significant change in the condition since the last inspection. (Refer to sketch for more details).

This girder is located above an expansion bearing.

Attachment Description: General view of the flagged condition at Girder G7 in Span 125 at Pier 124. Looking Begin.

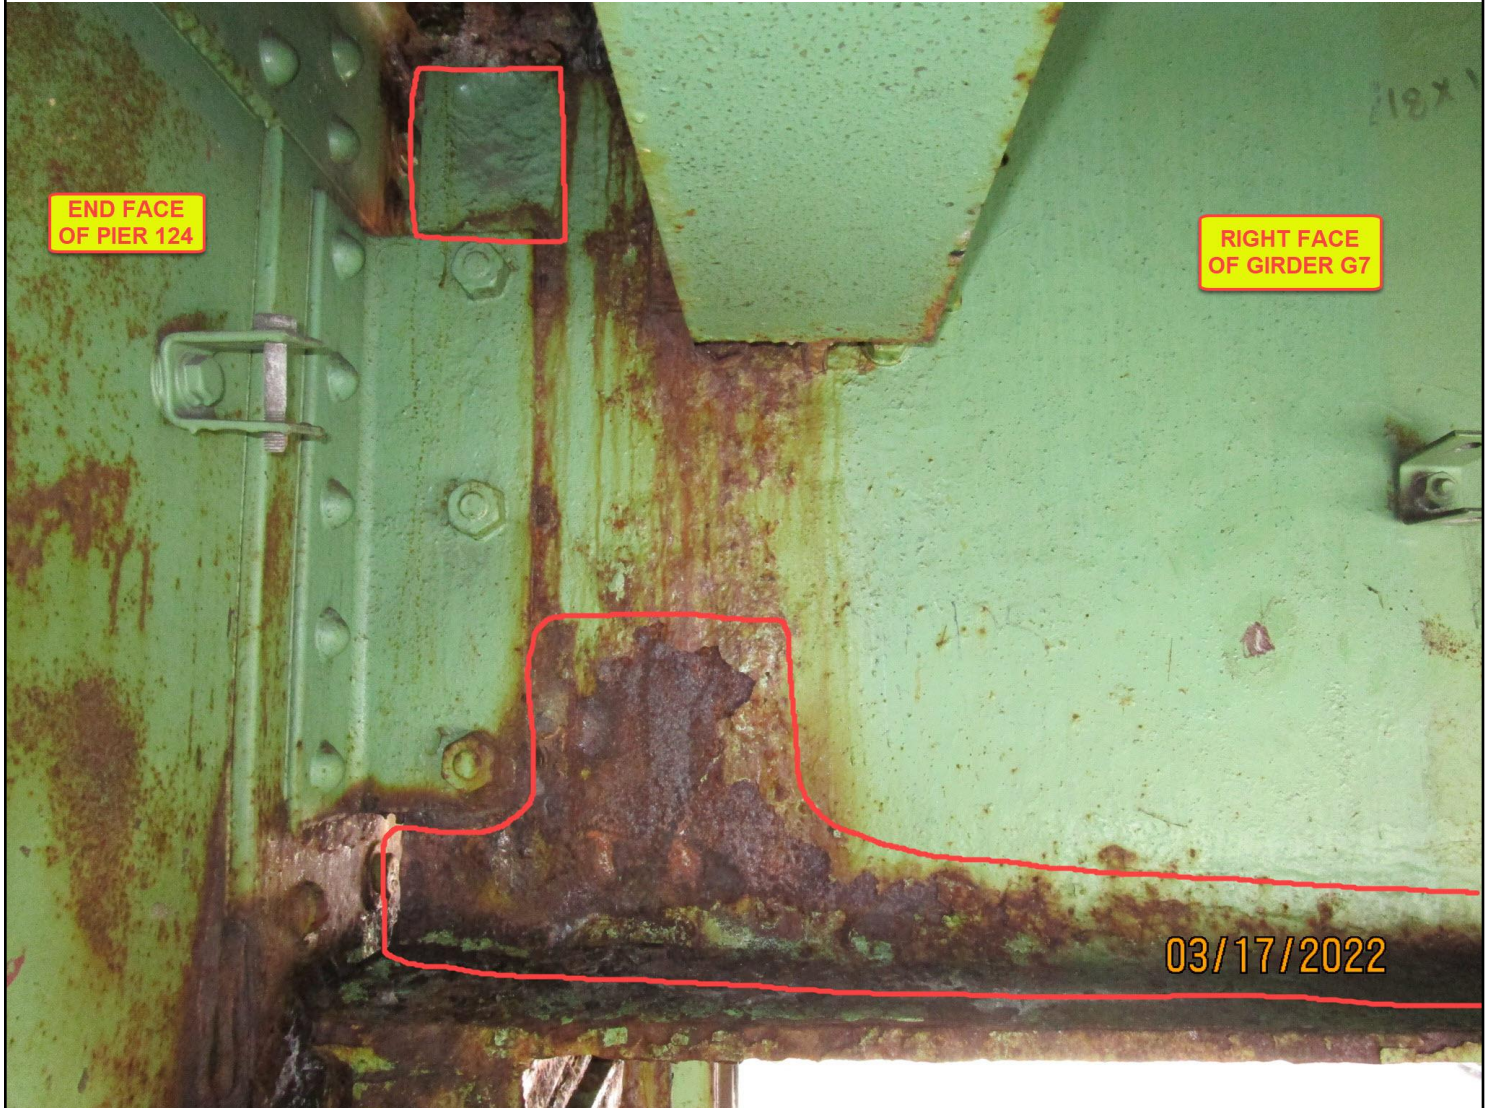
Photo Number: 3

Attachment Description: The right face of Girder G7 in Span 125 at Pier 124. The end of the girder exhibits severe section loss at the lower web above the bottom flange and web height adjacent to the guide angle. Looking Left.

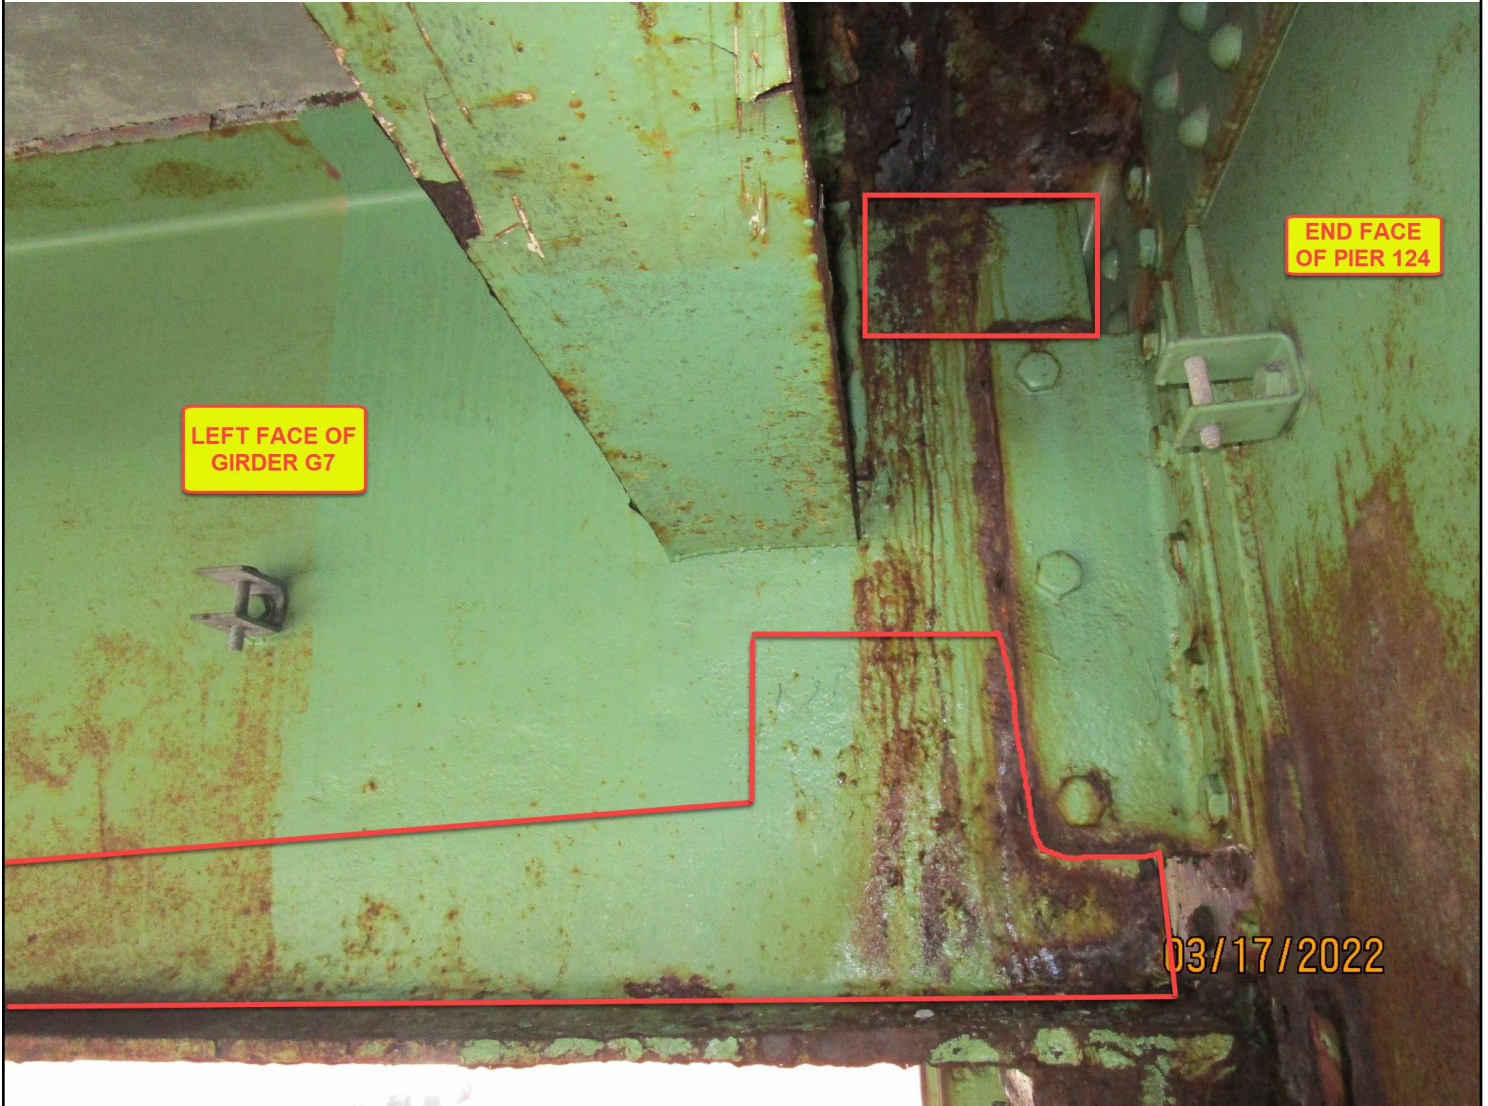
Photo Number: 4

Attachment Description: The left face of Girder G7 in Span 125 at Pier 124. The end of the girder exhibits severe section loss at the lower web above the bottom flange and web height adjacent to the guide angle. Looking Right.

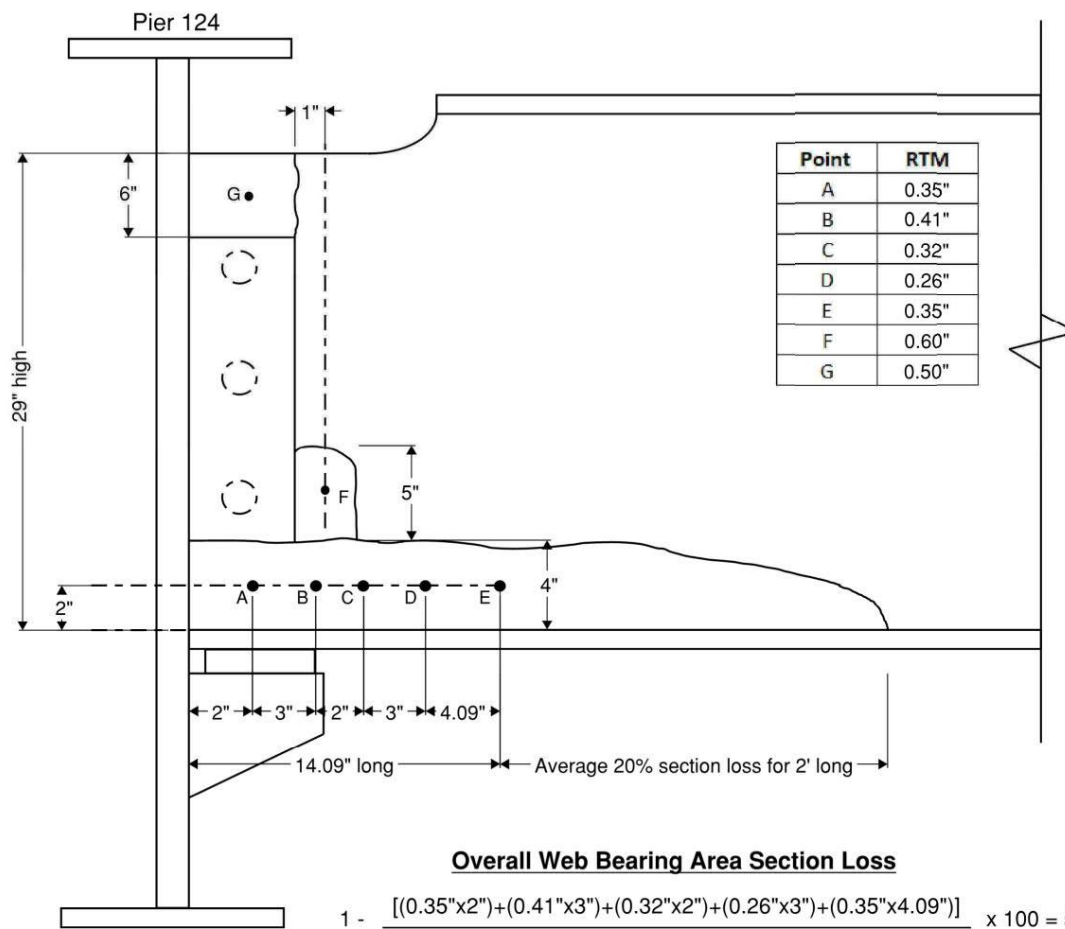
Right Face of Girder G7 Sketch in Span 125 at Pier 124

**Overall Shear Web Area Section Loss**

$$1 - \frac{[(0.35" \times 4") + (0.60" \times 5") + (0.50" \times 6") + (0.783" \times 14")]}{22.71 \text{ in}^2} \times 100 = 19\%$$

- As-built web thickness = 0.783"
- Length of bearing area = 18 x web thickness = 18 x 0.783" = 14.09"
- Overall bearing area = 14.09" x 0.783" = 11.03 in²
- As-built shearing web area = 29" x 0.783" = 22.71 in²
- Adjacent Girders G6 and G8 have previously installed reinforcement steel plates and angles at the end of the girders

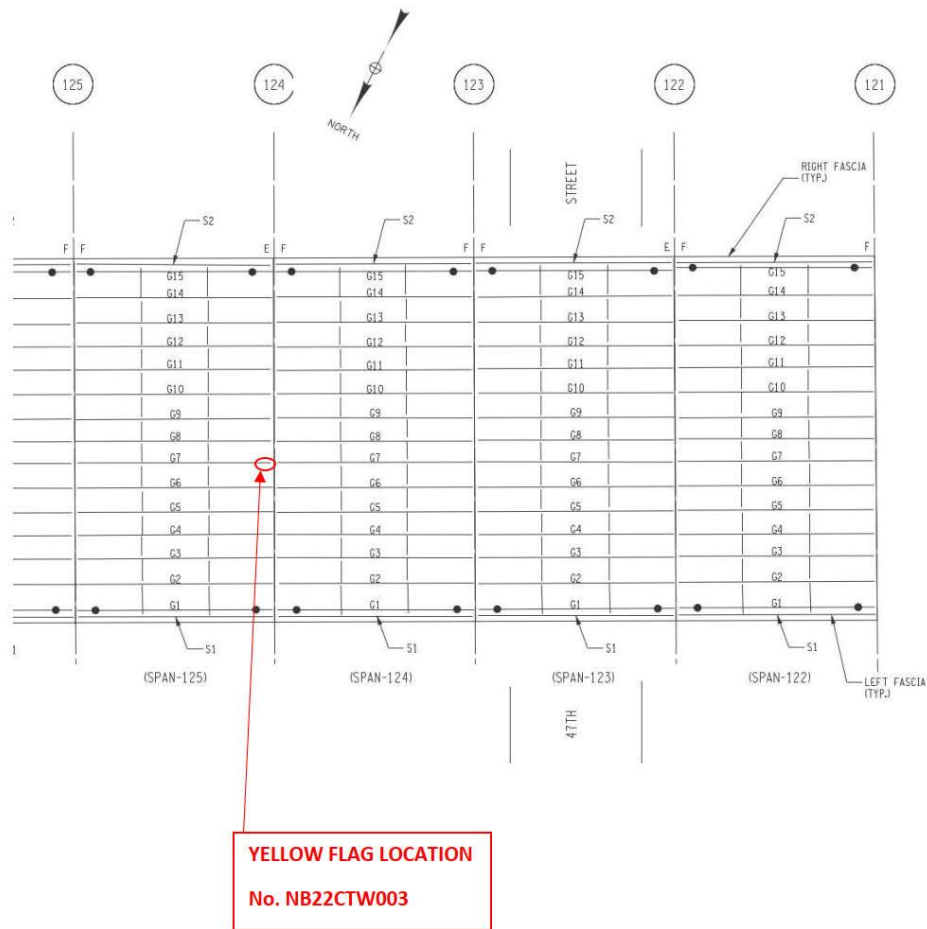
Photo Number: 6

Attachment Description: Span 125 G7 at Pier 124 Framing Plan
